**Flood Control Project Maintenance
Levee Inspections**

Fall 2019 Levee Maintenance Deficiency Summary Report

**Flood Control Project Maintenance
Levee Inspections****LMA District Cover Sheet****Fall 2019 Levee Inspection Results****Sacramento Maintenance Yard Maintenance Area 0004**

Sacramento Maintenance Yard Maintenance Area 0004

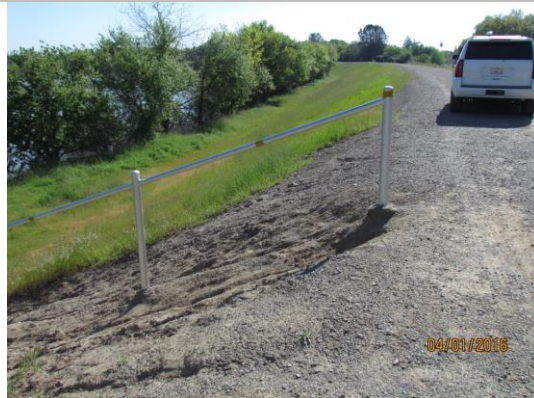
Photo 1 of 1 : FA_2019_MA0004_298_16_20190904_00009.jpg

View of the slope stability on the waterward side of the levee looking downstream. Spring 2016.

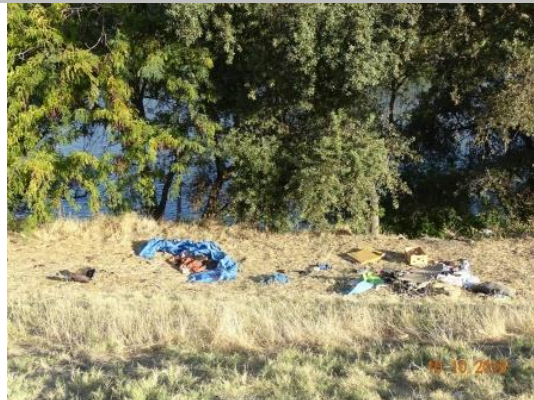
Photo 1 of 1 : FA_2019_MA0004_298_36_20191021_00043.jpg

View of debris and bbq grill on the waterside toe road. Fall 2019

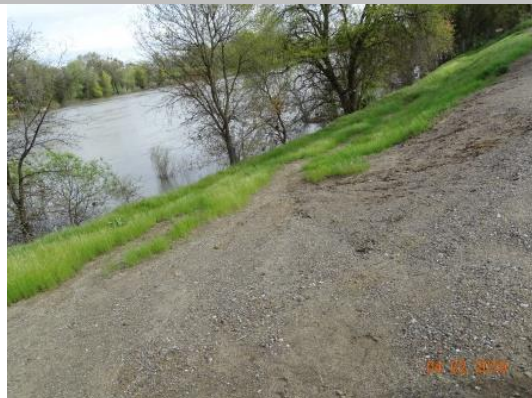
Photo 1 of 1 : FA_2019_MA0004_298_7_20190904_00002.jpg

LM Start	0.21	Rating **	A/W	Issue No.	7
LM End	0.22	Issue Type +	Ma	Location *	WS
Category	Earthen Levee			GPS Latitude/Longitude	
				Start	End
Item	Slope Stability			38.596840 °	38.596947 °
				-121.543848 °	-121.543727 °
DWR ID	DWR_MA0004_01_s_2019_7				
Comment Code					
S2 : Repair the levee slope damaged by foot traffic and prevent access where possible.					
Inspector Comment					
Monitor footpath and erosion on the waterside berm.

View looking north at footpath and erosion rills. Spring 2019

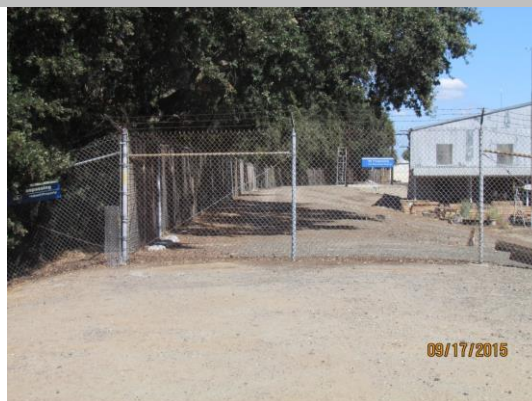
Photo 1 of 1 : FA_2019_MA0004_298_2_20190904_00001.jpg

LM Start	0.24	Rating **	U	Issue No.	2
LM End	0.24	Issue Type +	En	Location *	CR
Category	Earthen Levee			GPS Latitude/Longitude	
				Start	End
Item	Encroachments			38.597193 °	38.597193 °
				-121.543421 °	-121.543421 °
DWR ID	DWR_MA0004_01_s_2012_2				
Comment Code					
FE : Fence					
Inspector Comment					
This is the USACE yard, and the chain link fence crosses the levee. The fence runs the length of the yard on the crown.

View of the fence blocking access on the crown of the levee looking downstream. Fall 2015.

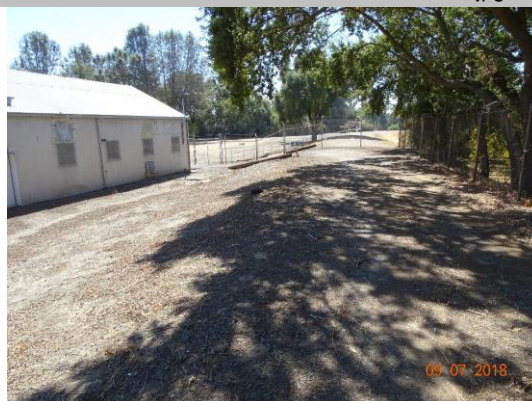
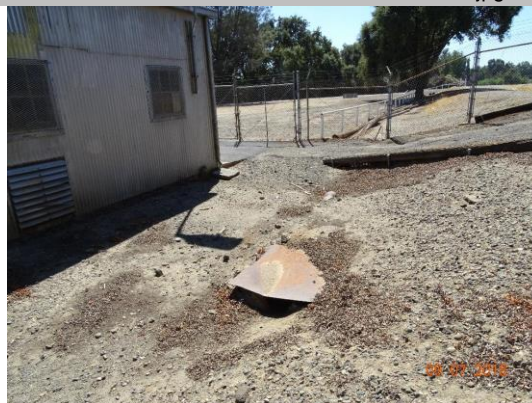
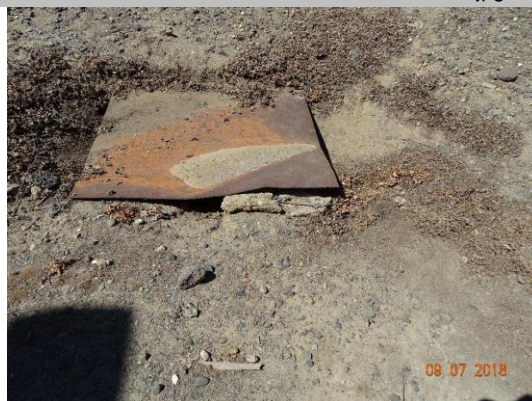
LM Start	0.25	Rating **	M	Issue No.	46	
LM End	0.25	Issue Type +	En	Location *		
Category	Supplemental			GPS Latitude/Longitude		
				Start	End	
Item	DRAFT DWR UCIP Field Study			38.597277 °	38.597277 °	
				-121.543264 °	-121.543264 °	
DWR ID	25546					
Comment Code						
Inspector Comment						
DS_ID:25546						
FS_ID:54261						
EP_NO: N/A						
Repair Type: Non-Urgent						
Crossing Status: Found						
UCIP Comments: 09/07/2018 Sediment clearing at pipe inlet is required. Pipe outlet is not visible on WS. O&M legacy system pipe. (O.Yakimov - DWR UCIP)						
FIELD_STRUCT_DESC: 12-inch corrugated metal drainage pipe through the levee, 19.0 feel below levee crown. [Additional Reference(s): USACE Sacramento O&M Manual 116, August 1955, Dwg No. 50-4-4179, page 9 of 19].						
FS Date: 9/7/2018

Levee crown near crossing

Covered concrete box at LS toe

Pipe inlet concrete box is covered with metal sheeting

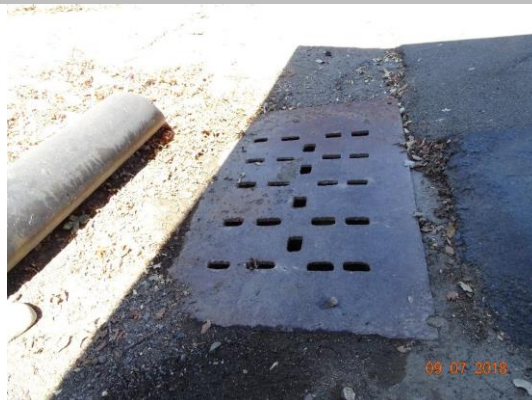
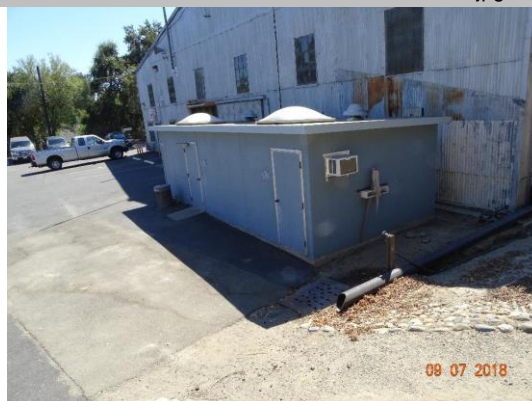
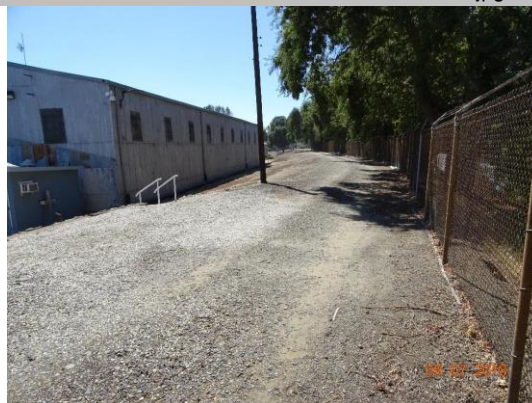
LM Start	0.32	Rating **	M	Issue No.	47
LM End	0.32	Issue Type +	En	Location *	
Category	Supplemental			GPS Latitude/Longitude	
				Start	End
Item	DRAFT DWR UCIP Field Study			38.597915 °	38.597915 °
				-121.542264 °	-121.542264 °
DWR ID	25545				
Comment Code					
Inspector Comment					
DS_ID:25545					
FS_ID:54262					
EP_NO: N/A					
Repair Type: Non-Urgent					
Crossing Status: Found					
UCIP Comments: 09/07/2018 Pipe not visible at WS slope. O&M legacy system pipe. (O.Yakimov - DWR UCIP)					
FIELD_STRUCT_DESC: 12-inch corrugated metal drainage pipe through the levee, 23.3 feel below levee crown. [Additional					
Reference(s): USACE Sacramento O&M Manual 116, August 1955, Dwg No. 50-4-4179, page 9 of 19].					
FS Date: 9/7/2018

Drainage pit at LS toe

DS_ID:25545
FS_ID:54262
EP_NO: N/A
Repair Type: Non-Urgent
Crossing Status: Found
UCIP Comments: 09/07/2018 Pipe not visible at WS slope. O&M legacy system pipe. (O.Yakimov - DWR UCIP)
FIELD_STRUCT_DESC: 12-inch corrugated metal drainage pipe through the levee, 23.3 feet below levee crown. [Additional Reference(s): USACE Sacramento O&M Manual 116, August 1955, Dwg No. 50-4-4179, page 9 of 19].
FS Date: 9/7/2018

Structures at LS toe where drainage pit is located

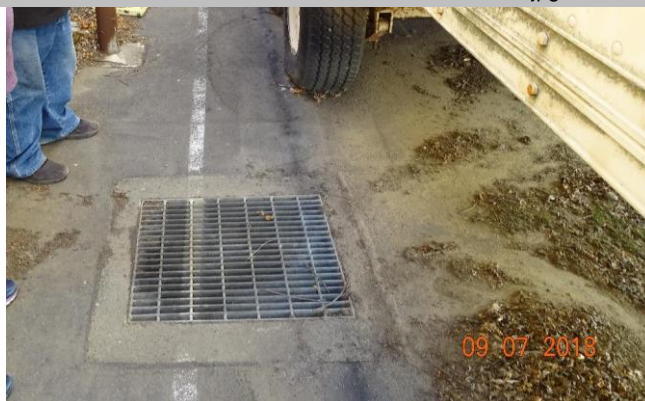
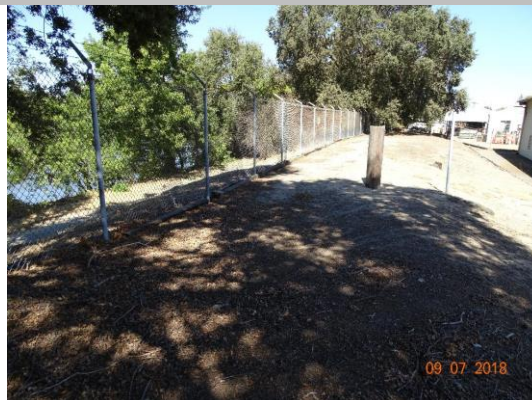
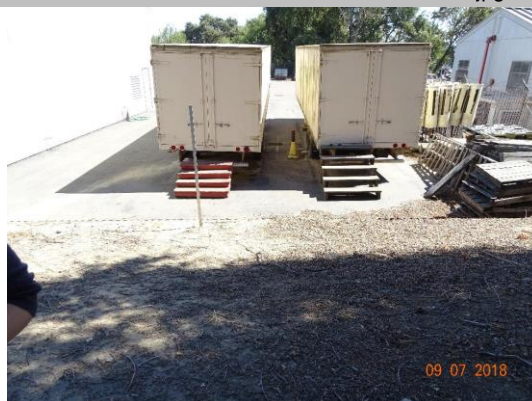
Comment Code					
Inspector Comment					
DS_ID:25547					
FS_ID:54255					
EP_NO: N/A					
Repair Type: Non-Urgent					
Crossing Status: Found					
UCIP Comments: 09/07/2018 Estimated to be 6-inch HDPE drainage pipe inside of drainage box on landside closer to levee toe. Unable to find permit for crossing modification to install HDPE pipe. (O.Yakimov - DWR UCIP)					
FIELD_STRUCT_DESC: 6-inch high-density polyethylene (HDPE) drainage pipe through the levee, unknown depth below levee crown. First drainage pit with grid is located in the middle of paved road, second is between 2 trailers toward levee toe inline with the first one.					
FS Date: 9/7/2018

Grided drainage pit between trailers on LS

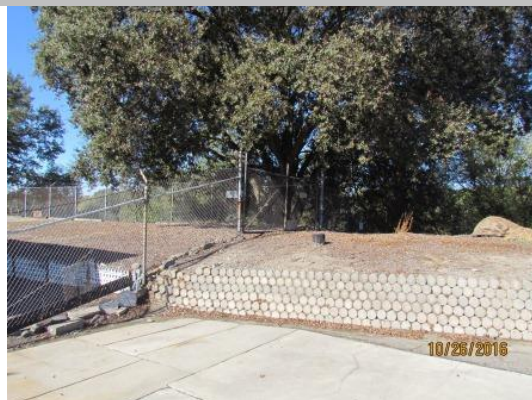
Photo 1 of 1 : FA_2019_MA0004_298_15_20190904_00008.jpg

View of fence crossing the crown on NE side of USACE facility. Fall 2016.

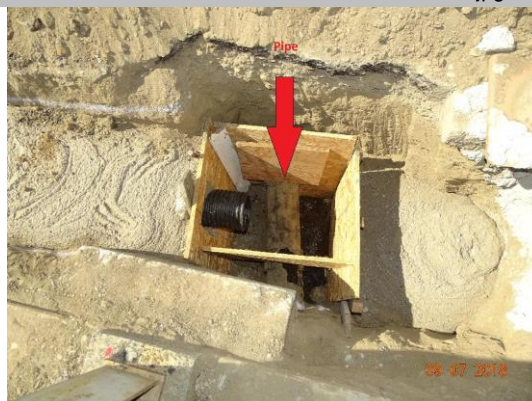
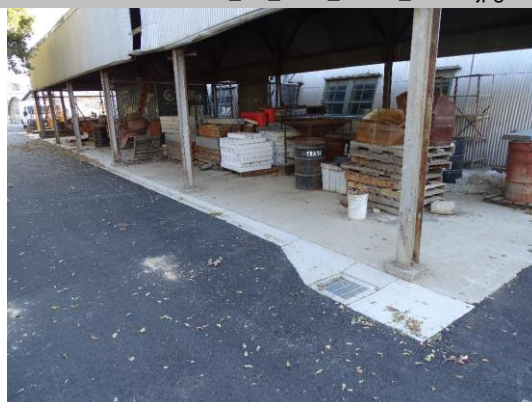
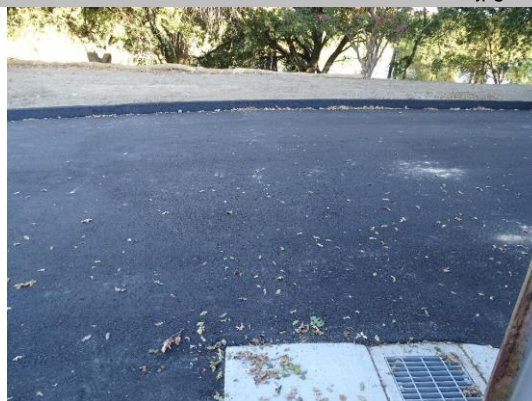
Comment Code						
Inspector Comment						
DS_ID:25544 FS_ID:55303 EP_NO: N/A Repair Type: Non-Urgent Crossing Status: Found UCIP Comments: 10/10/2019 According to FMO staff this pipe was disconnected from Sac Yard storm drainage system and grouted in place. Waiting for permit and as-builts that document pipe abandonment. (O.Yakimov - DWR UCIP)09/07/2018 Steel pipe at the bottom of drainage box is visible. Large reconstruction project is going on the property. Contact Brian Murphy with FMO after work is completed to request as-builts. (O.Yakimov - DWR UCIP) FIELD_STRUCT_DESC: 8-inch steel drainage pipe through the levee, 12.1 feel below levee crown. [Additional Reference(s): USACE Sacramento O&M Manual 116, August 1955, (Station 53+72), Dwg No. 50-4-4179, page 9 of 19]. FS Date: 10/10/2019 8:51:06 AM

8-inch steel pipe at the bottom of drainage box on LS goes towards levee

View of drainage box on levee crown

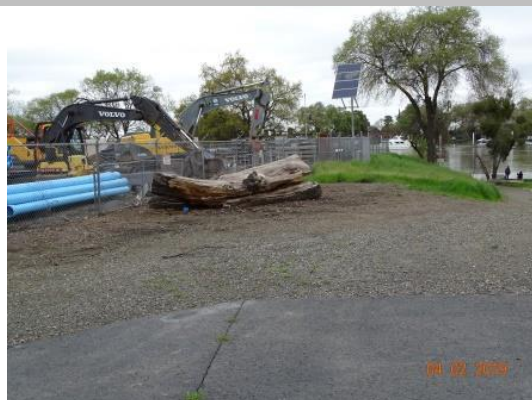
Photo 1 of 1 : FA_2019_MA0004_298_30_20190904_00021.jpg

LM Start	0.76	Rating **	M	Issue No.	30
LM End	0.76	Issue Type +	Ma	Location *	WS
Category	Earthen Levee			GPS Latitude/Longitude	
				Start	End
Item	Encroachments			38.601353 °	38.601353 °
				-121.536140 °	-121.536140 °
DWR ID	DWR_MA0004_01_s_2019_30				
Comment Code					
TR : Tree or limb					
Inspector Comment					
Remove tree log from the levee easement.

View looking north at tree log on waterside easement. Spring 2019

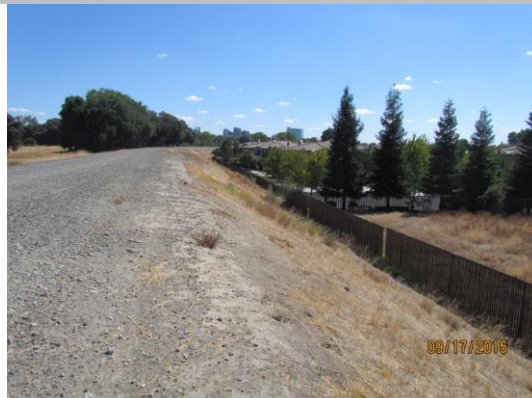
Photo 1 of 1 : FA_2019_MA0004_298_14_20190904_00007.jpg

View of the fence running along the toe of the landward side of the levee looking downstream. Fall 2015.

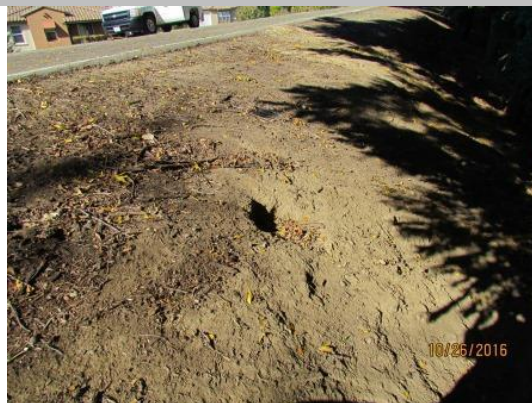
Photo 1 of 1 : FA_2019_MA0004_298_18_20190904_00011.jpg

View of animal holes on the WS slope. Fall 2016.

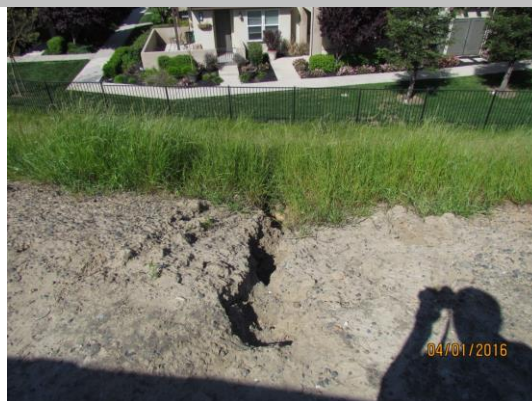
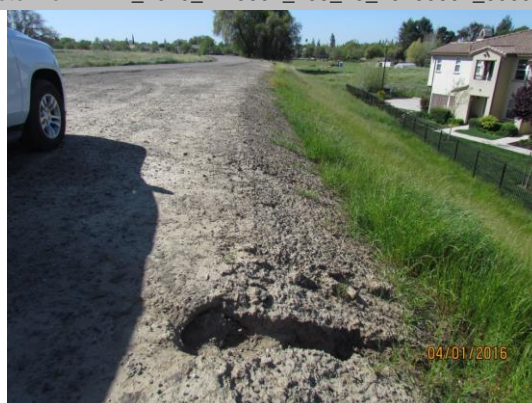
LM Start	2.18	Rating **	M	Issue No.	13
LM End	2.18	Issue Type +	Ma	Location *	LS
Category	Earthen Levee			GPS Latitude/Longitude	
				Start	End
Item	Erosion / Bank Caving			38.597932 °	38.597932 °
				-121.512887 °	-121.512887 °
DWR ID	DWR_MA0004_01_s_2015_13				
Comment Code					
E2 : Schedule repair of erosion site prior to the next inspection.					
Inspector Comment

Runoff erosion is on the shoulder of the landward side. Spring 2016.

Perspective view of the runoff erosion on the landward side of the levee looking downstream. Spring 2016.

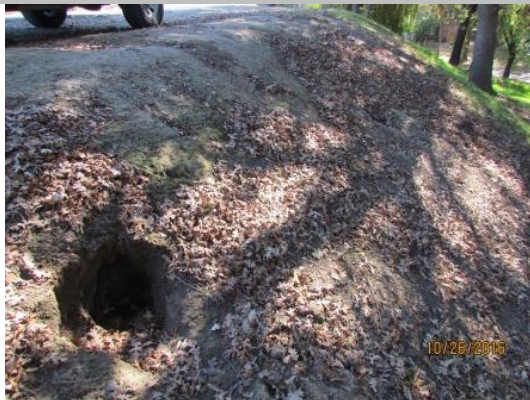
Photo 1 of 1 : FA_2019_MA0004_298_20_20190904_00012.jpg

Large diameter animal burrows on LS slope. Fall 2016.

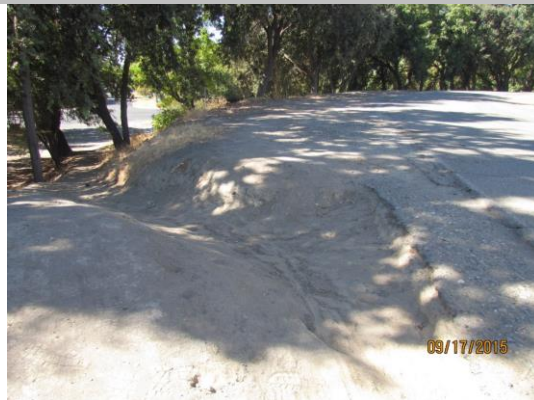
Photo 1 of 1 : FA_2019_MA0004_298_22_20190904_00014.jpg

View looking upstream of the depression on the landward side of the levee due to foot traffic. Fall 2015.

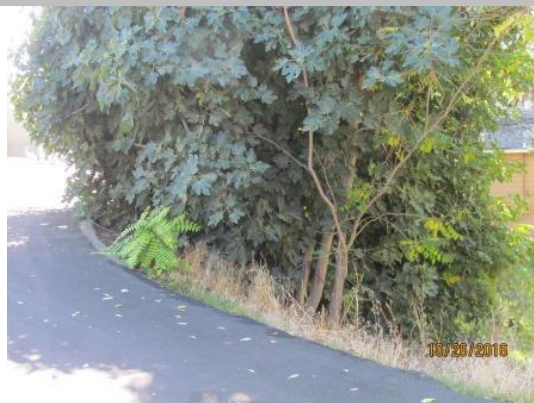
Photo 1 of 1 : FA_2019_MA0004_298_21_20190904_00013.jpg

View of small trees that block visibility of LS slope. Fall 2016.

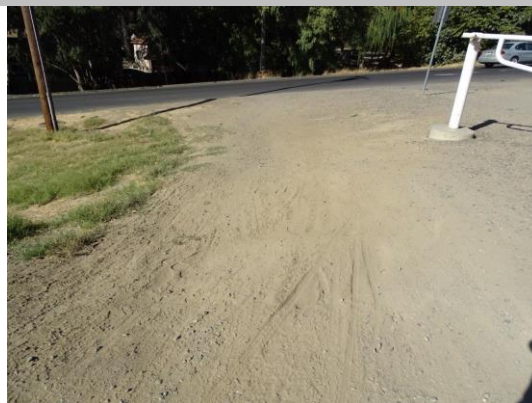
Photo 1 of 1 : FA_2019_MA0004_298_17_20190904_00010.jpg

View of slope damage from vehicular traffic bypassing gate. Fall 2018

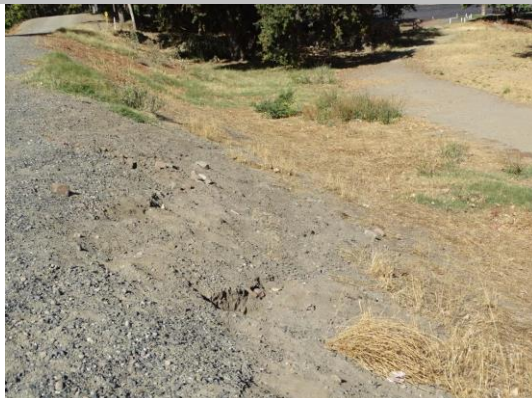
Photo 1 of 1 : FA_2019_MA0004_298_25_20190904_00017.jpg

View of slope damage from vehicular traffic. Fall 2018

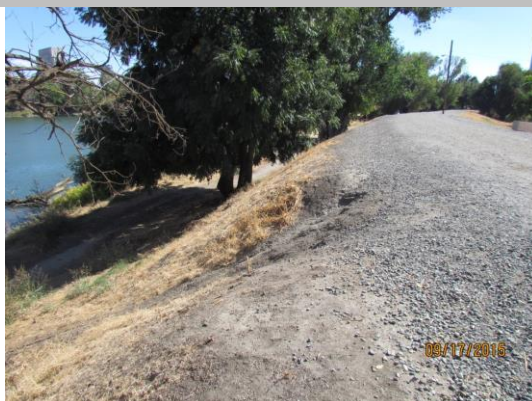
Photo 1 of 1 : FA_2019_MA0004_298_24_20190904_00016.jpg

View looking downstream at the slope stability issue due to foot traffic on the waterward side of the levee . Fall 2015.

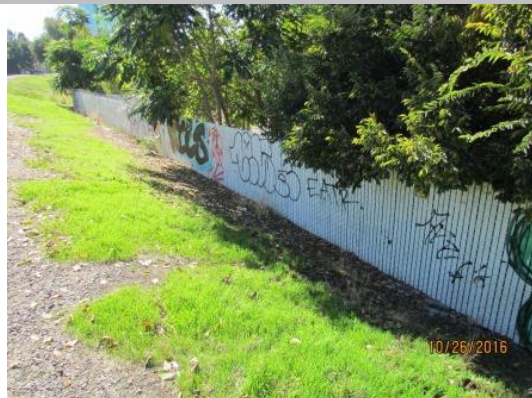
Photo 1 of 1 : FA_2019_MA0004_298_23_20190904_00015.jpg

View of fence on LS slope. Fall 2016.

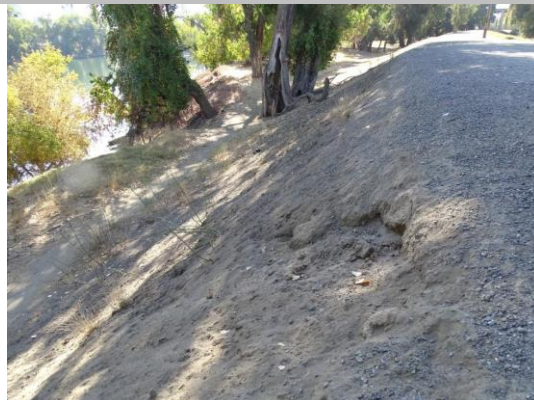
Photo 1 of 1 : FA_2019_MA0004_298_28_20190904_00020.jpg

View of slope damage from foot traffic. Fall 2018

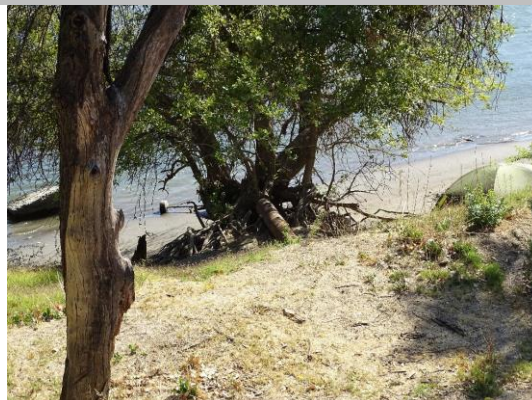
Photo 3 of 3 : UCIP_FA_2019_55314_81575.jpg

Water side view: abandoned and grouted 10-inch pipe

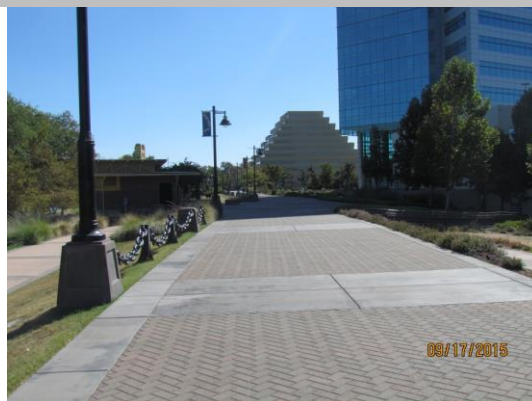
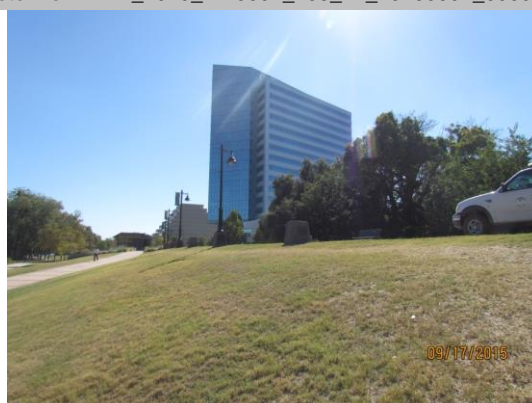
The Riverwalk is part of the landscape on the levee. Fall 2015.

Landscaping and buildings are on the crown and waterward side of the levee. Fall 2015.

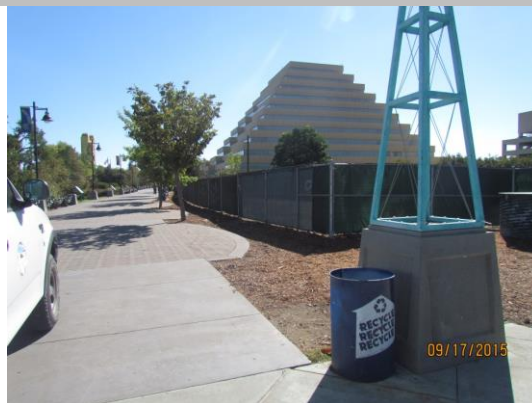
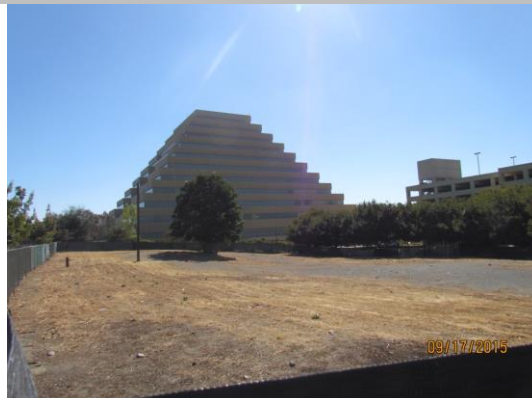
View looking downstream at the fence on the crown of the levee . Fall 2015.

View looking downstream at the inside of the fence. Fall 2015.
